# Manhole Inspection Summary

Manhole # S35U\_\_006MH

Insp Date: **3/20/08 8:09 AM**

**Location** Address: **1605 s hanover st**

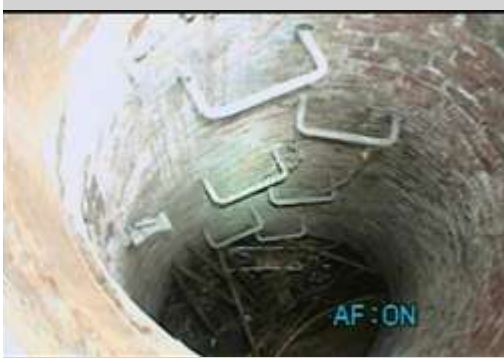
Defect 1

Count: **6** Missing: **0** ☒ **Corroded**

debris, corroded stairs

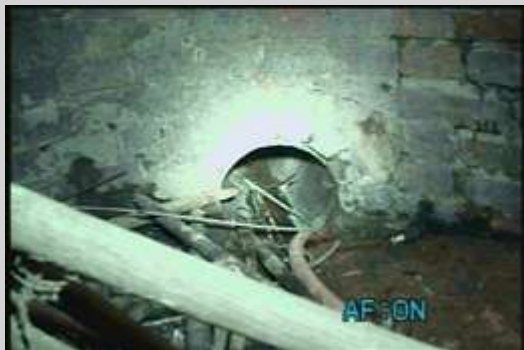
12 O'Clock Outflow

8 in. Circular Gravity Sewer  
Pipe Out @ 12 O'Clock

Deposits: ☒ None ☐ Mud ☐ Sludge ☐ Debris ☐ Grease

Infiltration: **None** Pipe Seal Cond: **Unknown**
